# **WATER RESOURCES IN THE CULTIVATED UPLANDS OF LAO PDR - A CASE STUDY OF HUAY MAHA VILLAGE**

**A Minor Field Study**

**TRITA-LWR Master Thesis**

LWR-EX-07-28

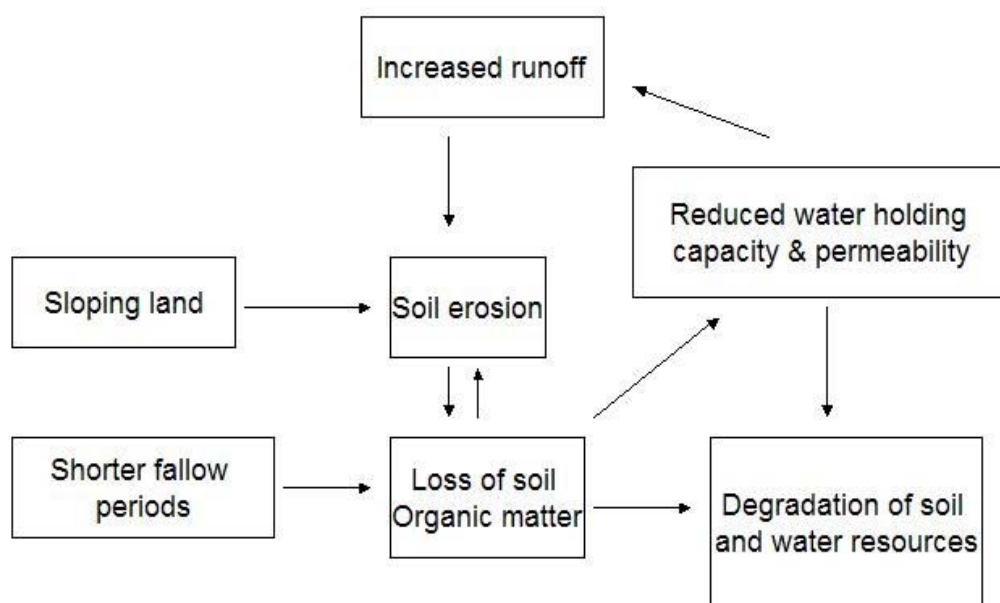
**Fig. 4. A simplified model of how land use changes, soil and water properties and soil erosion interacts. Based on Young's (1989) description.**

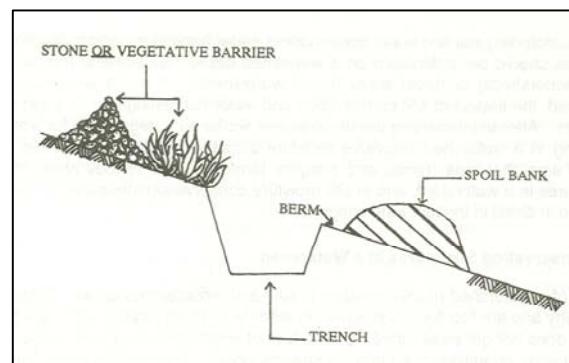
**Fig. 8. Model of how a contour trench can be constructed (Sivanappan 1992)**

*Contour trenching* slow down the runoff by breaking the slope at certain intervals. The trench should be constructed with a barrier of stones or vegetation upstream the trench to capture sediments (Fig. 8). Cross sections typically range between 1000-2500 cm<sup>2</sup> and can be as short as 3.5 m to several hundred meters long (Sivanappan 1992). The vertical and horizontal distances between the structures depend on precipitation, slope and soil depth. The location should be chosen to maximise runoff capture (Fig. 9) (Sivanappan 1992).

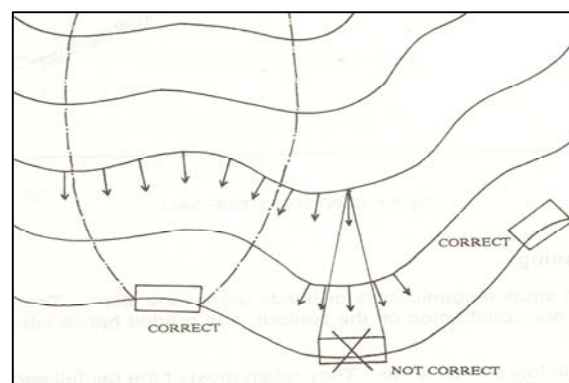
**Fig. 9. Illustration of correct and not correct location of trenches, in order to collect as much water as possible. (Sivanappan 1992)**

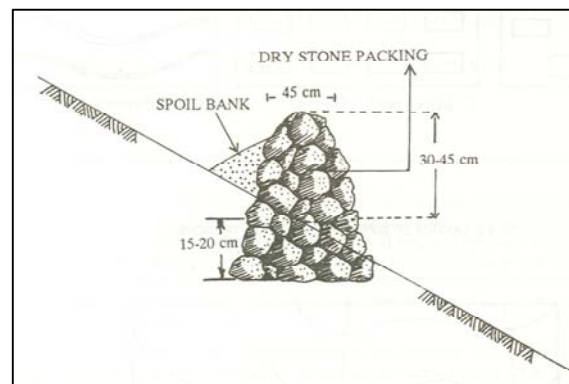
**Fig. 10. Model of how bunds can be dimensioned (Sivanappan 1992)**

Another method to cut the slope in intervals is by constructing *contour bunds*. The bund can be constructed with stones and is partly cut into the slope to gain stability (Fig. 10). This method is recommended only for fields with slope less than 5 % (Sivanappan 1992).

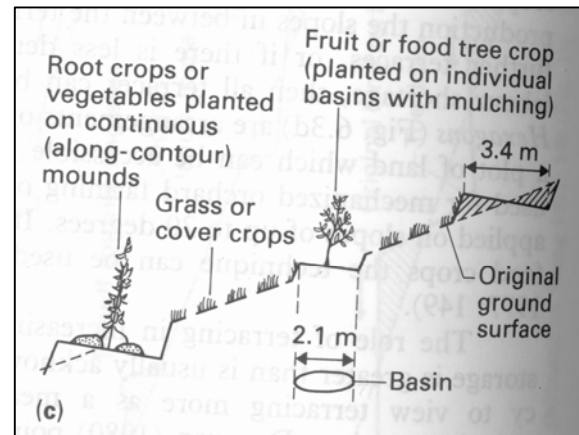
Fig. 11. Illustration of mini-convertible terraces (Barrows 1987).

*Terraces* exist in many different designs. They can be horizontal, inward sloping or outward sloping. One method of runoff harvesting recommended by Barrow (1987) on slopes with 7-30° gradient is the reverse-sloping bench terraces. This is appropriate in humid tropics where surplus runoff may be a problem at times. According to Singh & Singh (2000) reverse sloping terraces is appropriate in high rainfall areas with low permeability on gradients 6-33 %. A variety of this is the so-called mini-convertible terraces (Fig. 11).

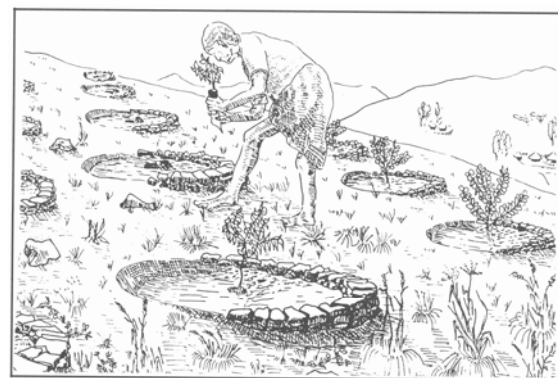
Fig. 12. Illustration of micro basins (Moldenhauer & Hudson 1988).

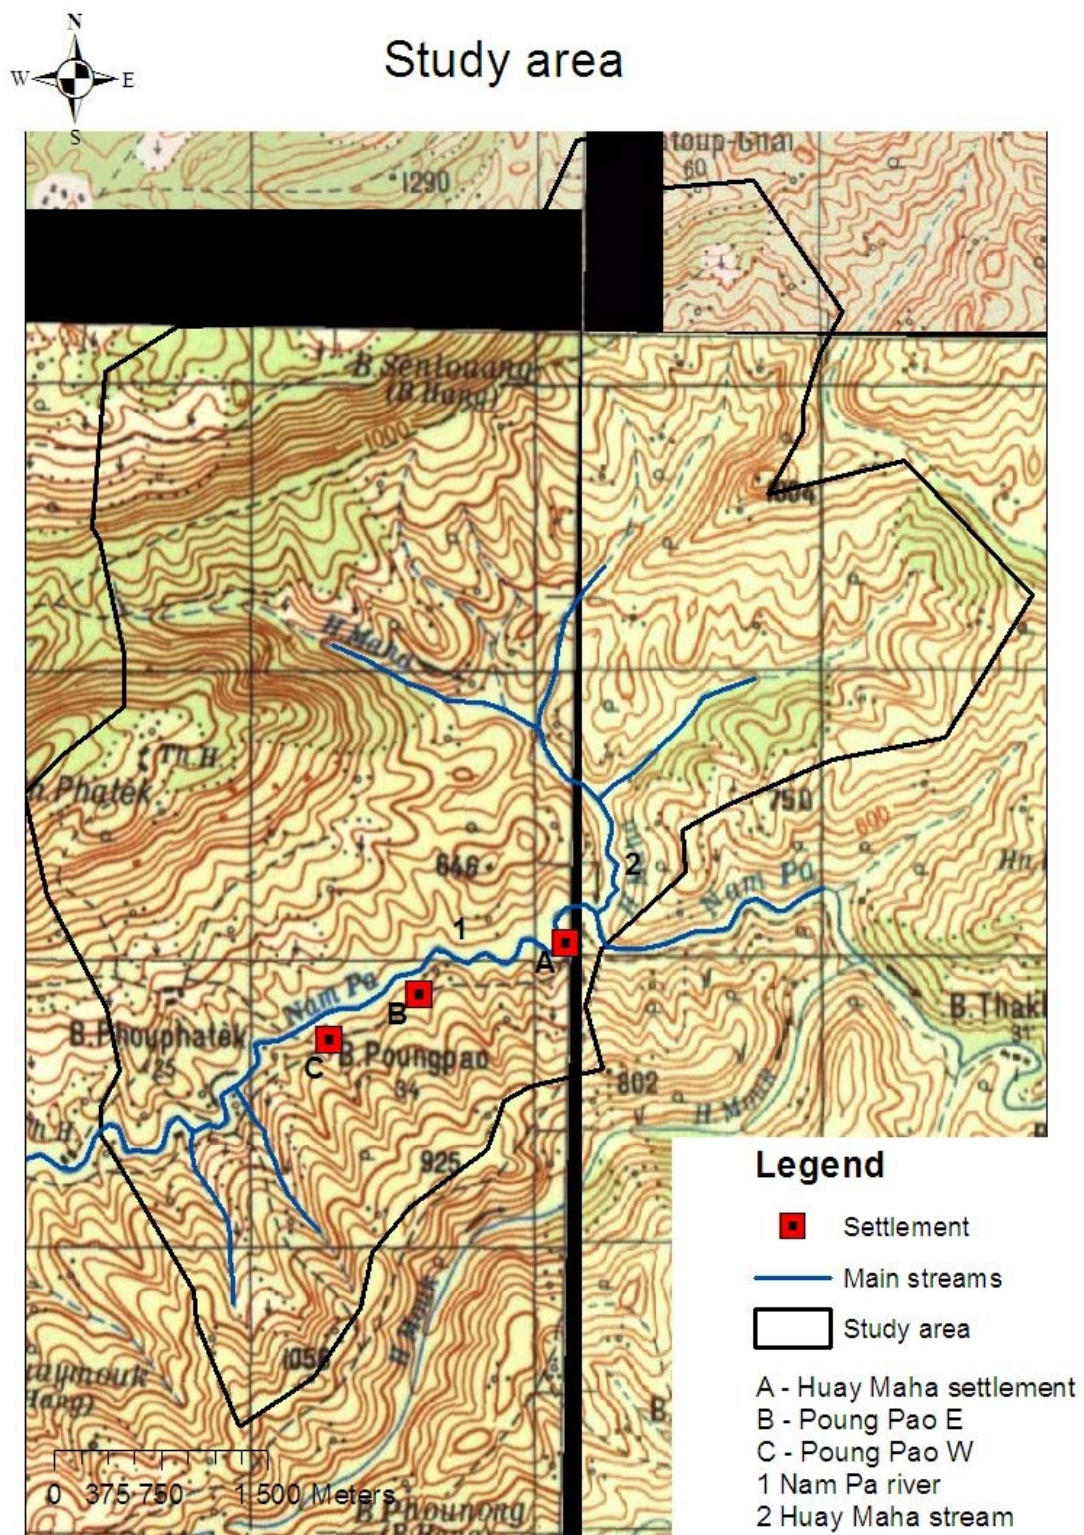
Fig. 13. Topographic map over the study area with the boundaries of the “catchment”, the settlements and main streams highlighted (Data modified from NAFRI 2006).

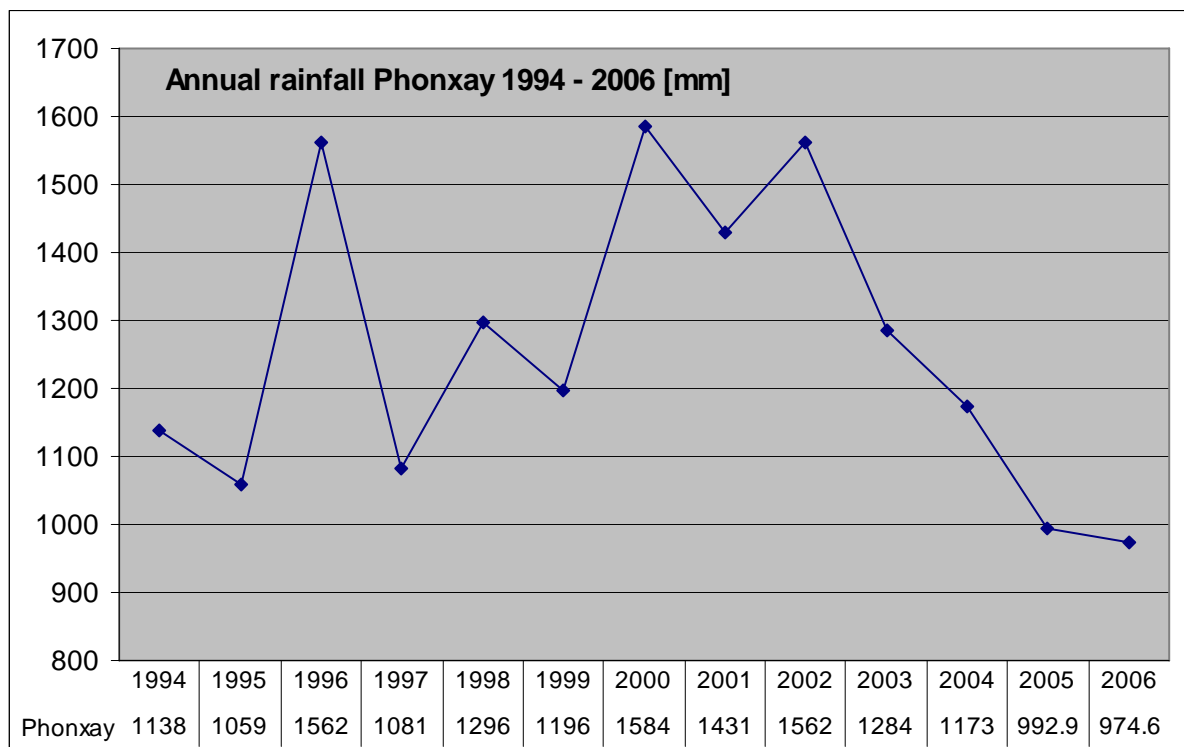
Fig. 14. Annual rainfall distribution in Phonxay district (District Agriculture and Forestry Extension Office 2006).

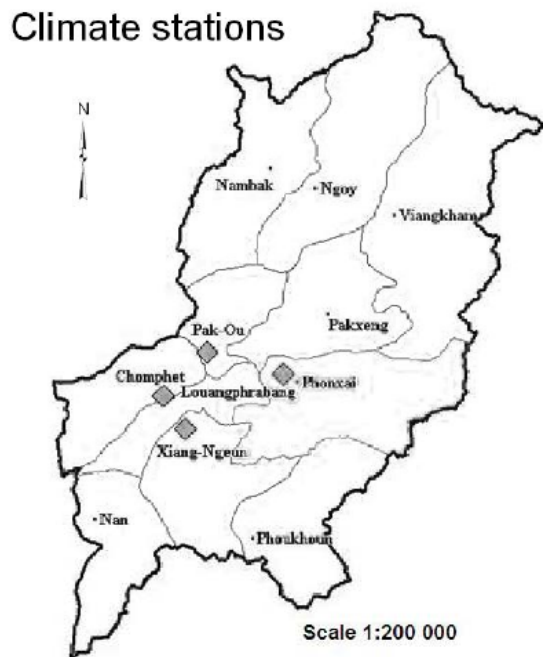
Fig. 15. Map of Luang Prabang Province marked with location of climatic stations from which data has been used (Luang Prabang, Pak Ou, Phonxay & Xieng-Ngun) (Map modified from NAFRI 2006).

Data were also collected from three different climate stations in and around Luang Prabang: Luang Prabang, Xiengngun and Pak Ou (Fig. 15). The climate station in Luang Prabang is situated at about 300 m a s l, the one in Pak Ou at 360 m a s l and the one in Xiengngun at 380 m a s l. The amount of rainfall in Luang Prabang and Pak Ou are quite similar, and their precipitation curves synchronize fairly well (Fig. 16). The rainfall curve for Xiengngun is similar to the other two, but with a constant lower precipitation between April-October (Fig. 16). The rainfall in August is noticeable higher in Phonxay than in the other places, especially compared to Xiengngun (Fig. 16).

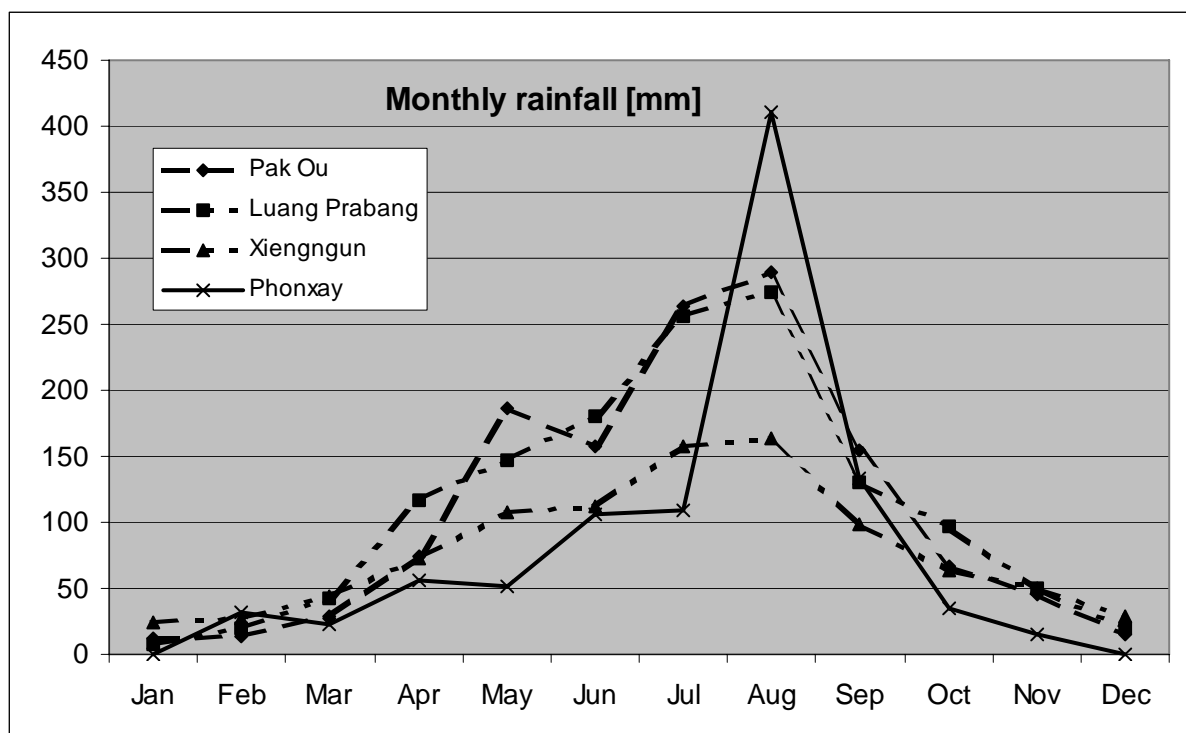
Fig. 16. Comparison of monthly precipitation for different climate stations in the region. The values from Xiengngun are based on average monthly data 1998-2005 (Appendix III). The values from Pak Ou were collected 1992-2004, and the data from Luang Prabang originate from 1985-1998 (Appendix III). The data from Phonxay are based on daily measurements 2005-2006 (Appendix II). (Agro-metrology station Luang Prabang 2006: District Agriculture and Forestry Extension Office 2006 ).

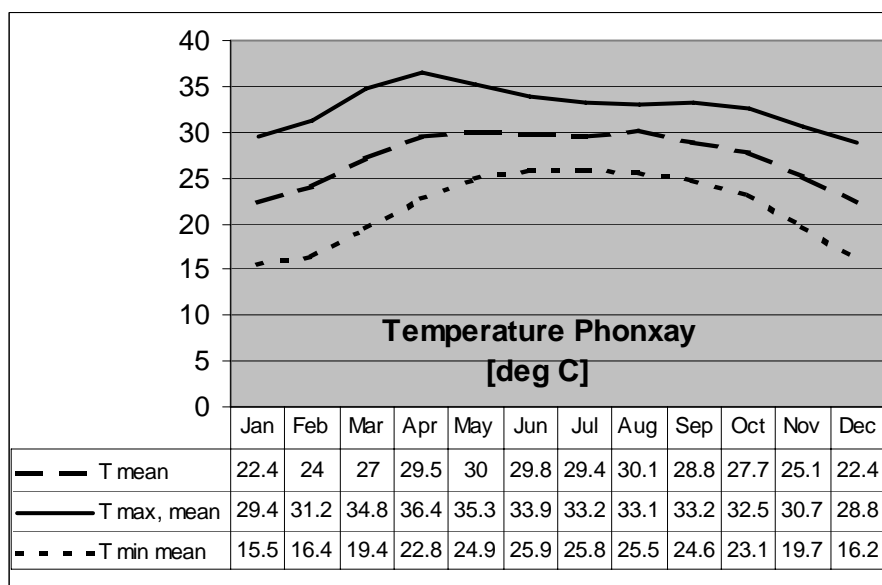
Fig.17. Temperature distribution in Phonxay district. Data interpolated by Nilsson & Svensson (2005) from 34 different climate stations in Southeast Asia. All values represent the temperature at sea level.

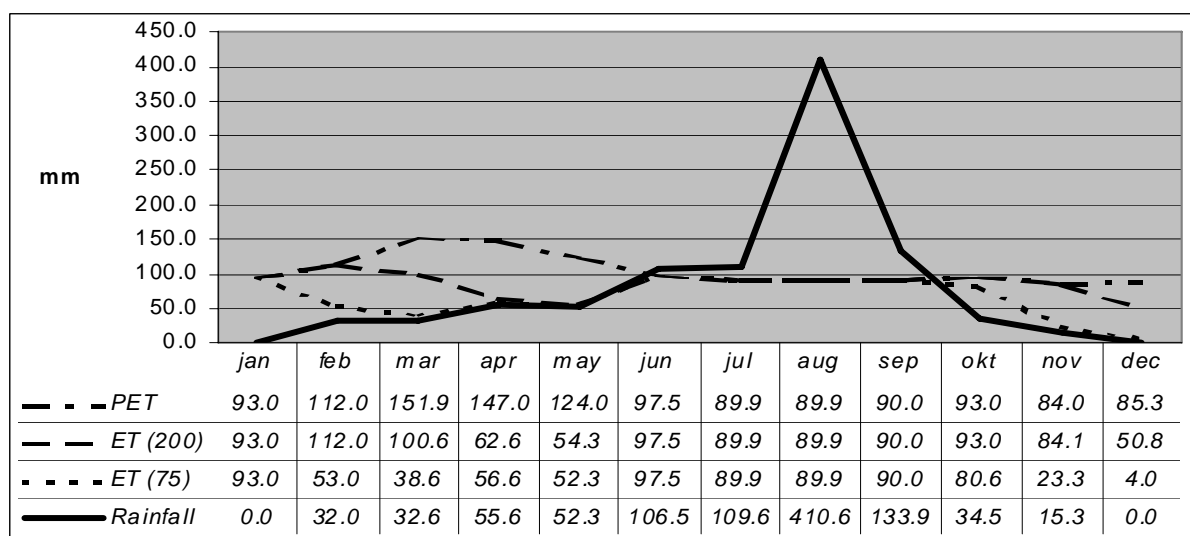
Fig. 18. Rainfall data over Phonxay in relation to the potential evapotranspiration (PET) and the calculated values of actual evapotranspiration (ET) with the two different root constant values of 200 and 75 mm, referring to woodland and grassland (Raw data regarding rainfall from District Agriculture and Forestry Extension Office 2006, PET from Nilsson & Svensson (2005) Appendix IV, ET calculations in Appendix V and RC values from Shaw (1994)).

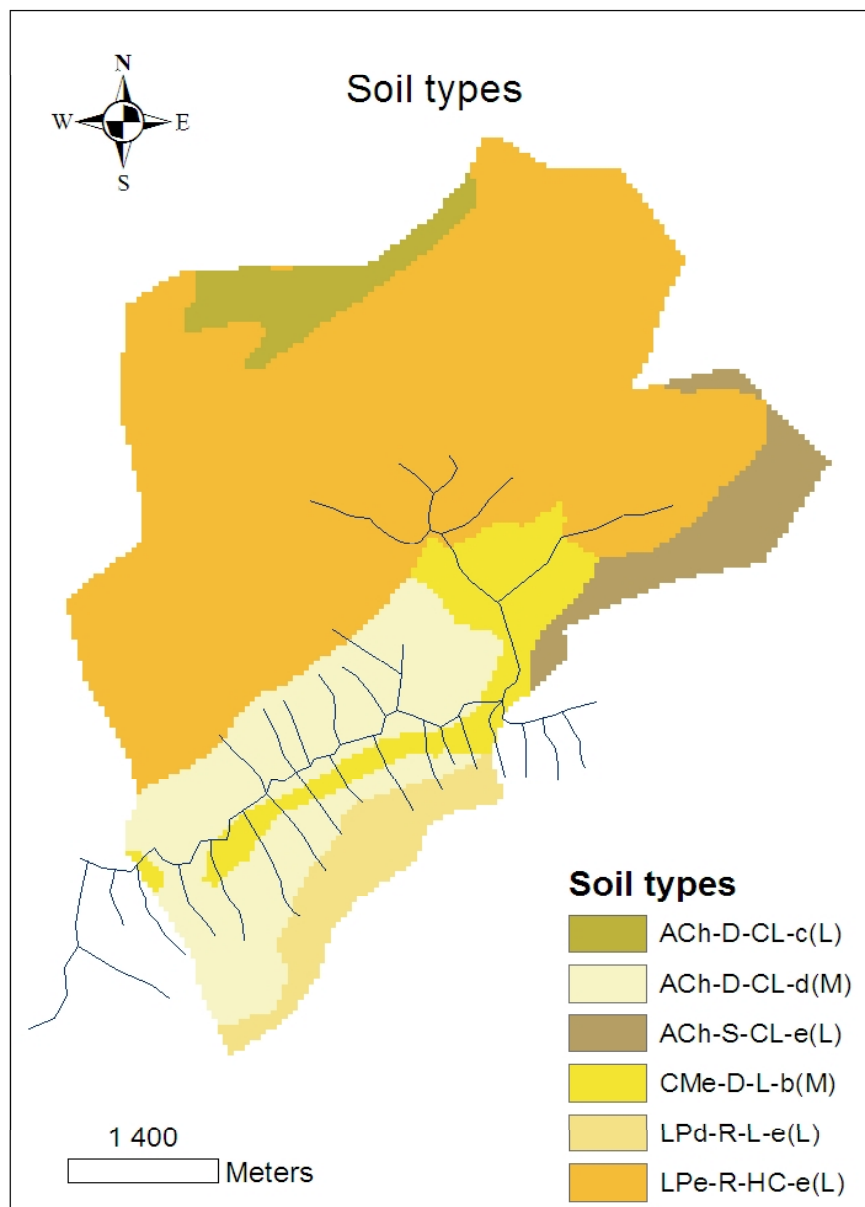
**Fig. 19. Soil types in the study area.** (Source: Soil Survey and Land Use Classification Center, SSLCC) The acronyms in the soil types legend should be read as follows; ACh: Acrisols - D: deep (>100 cm depth) - CL: clay loam - c : (rolling (slope 16-30%) - (L): Low fertility rate . All the acronyms are shown in table 9.

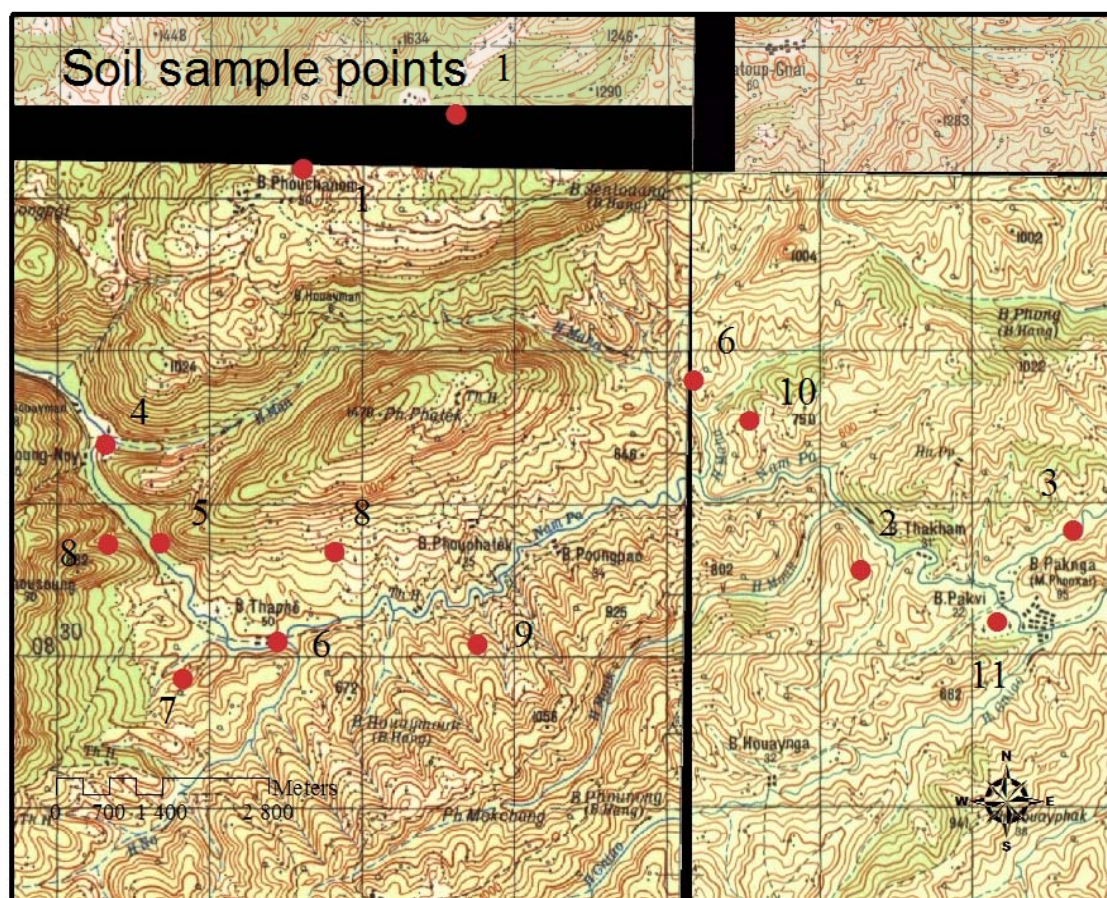
*Fig. 20. The location of eleven different soil mapping units identified from fourteen different soil samples by Soil Survey and Land Classification Centre (SSLCC) at NAFRI, within or close by the study area.*

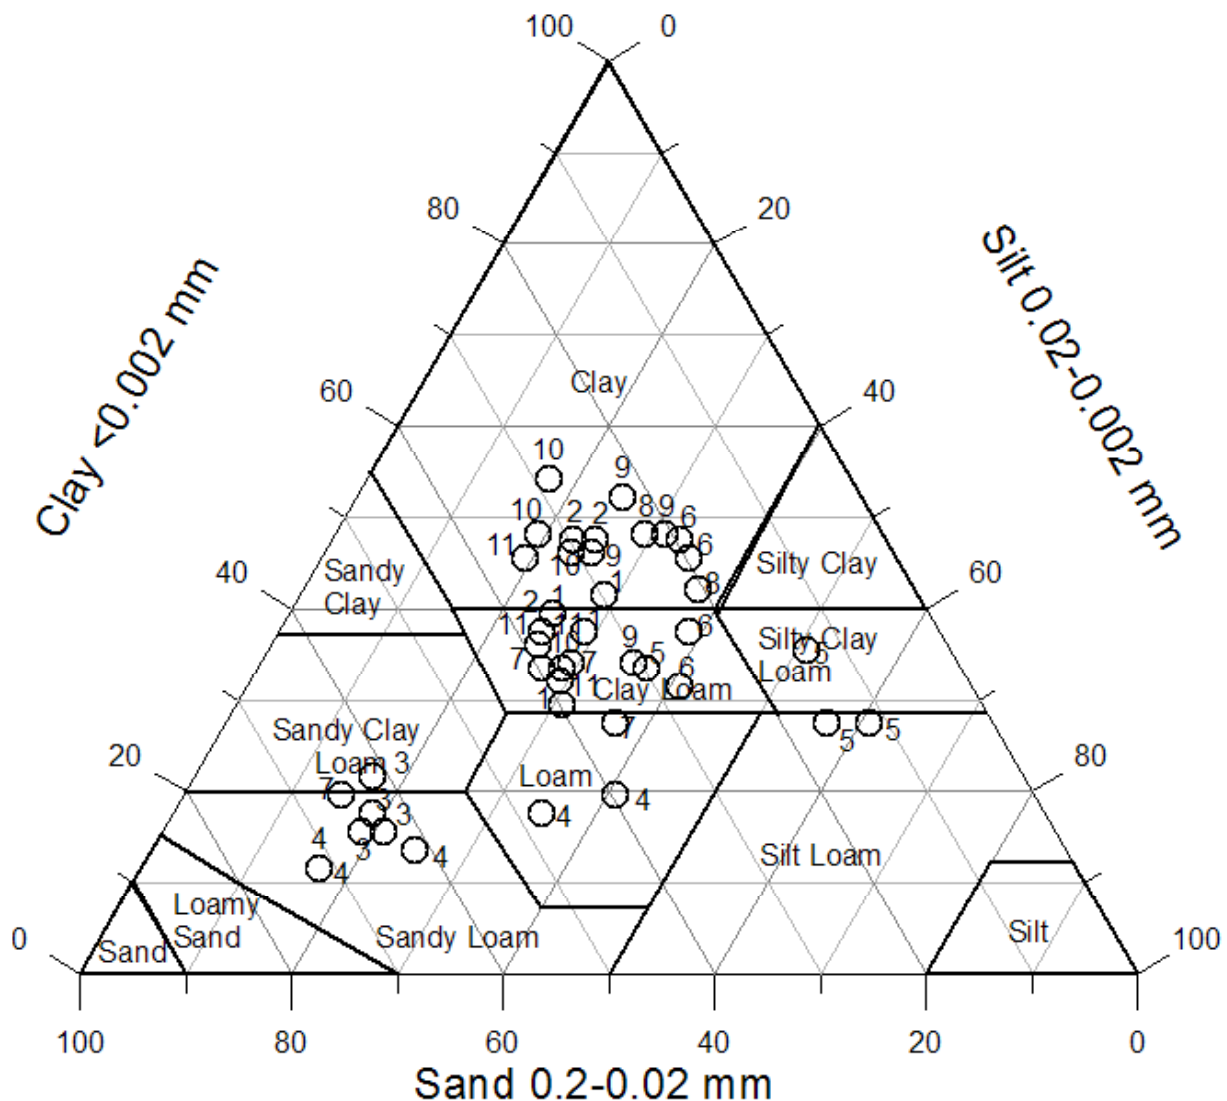
Fig. 21. Textural distribution of the soil samples taken by SSLCC, put in a ternary diagram by the authors. The soil definition is done by the United States Department of Agriculture, USDA, classification (Shaw 1994)

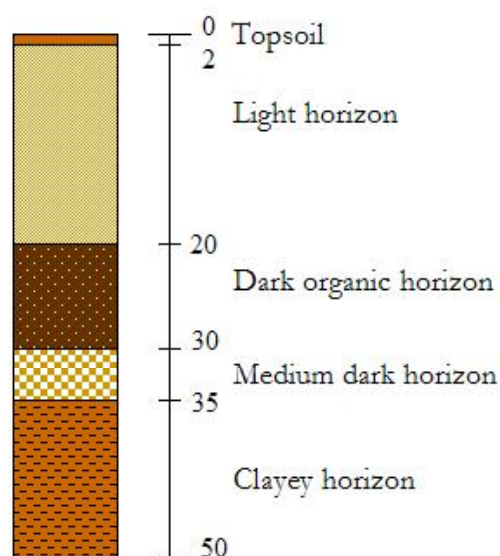
**Fig. 22 Soil profile at the shore of Nam Pa 100 m upstream of intersection with Huay Maha. (Location 1 19 57 48 N, 102 30 04 E).**

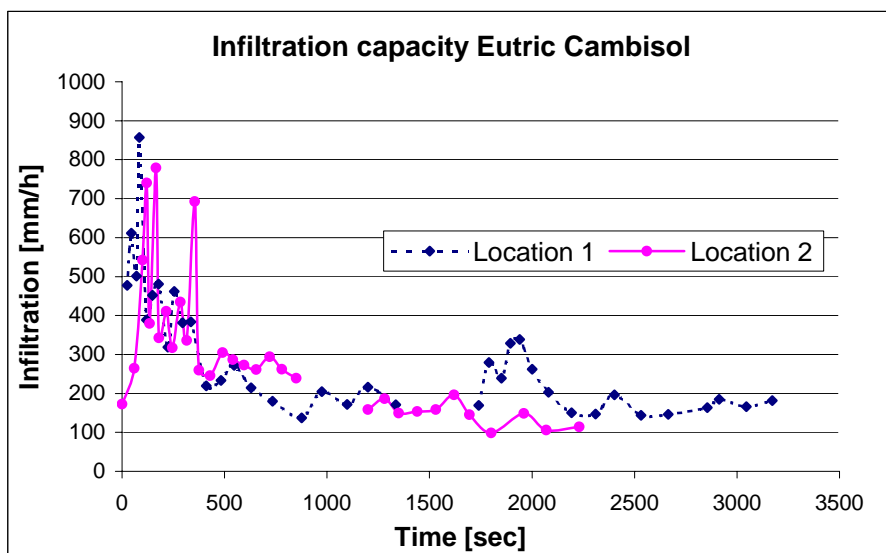
**Fig. 23. Infiltration capacities measured by the authors. Location 1 is on the shore of Nam Pa, 100 m upstream of intersection with Huay Maha. Location 2 is in Pong Pao W settlement. .**

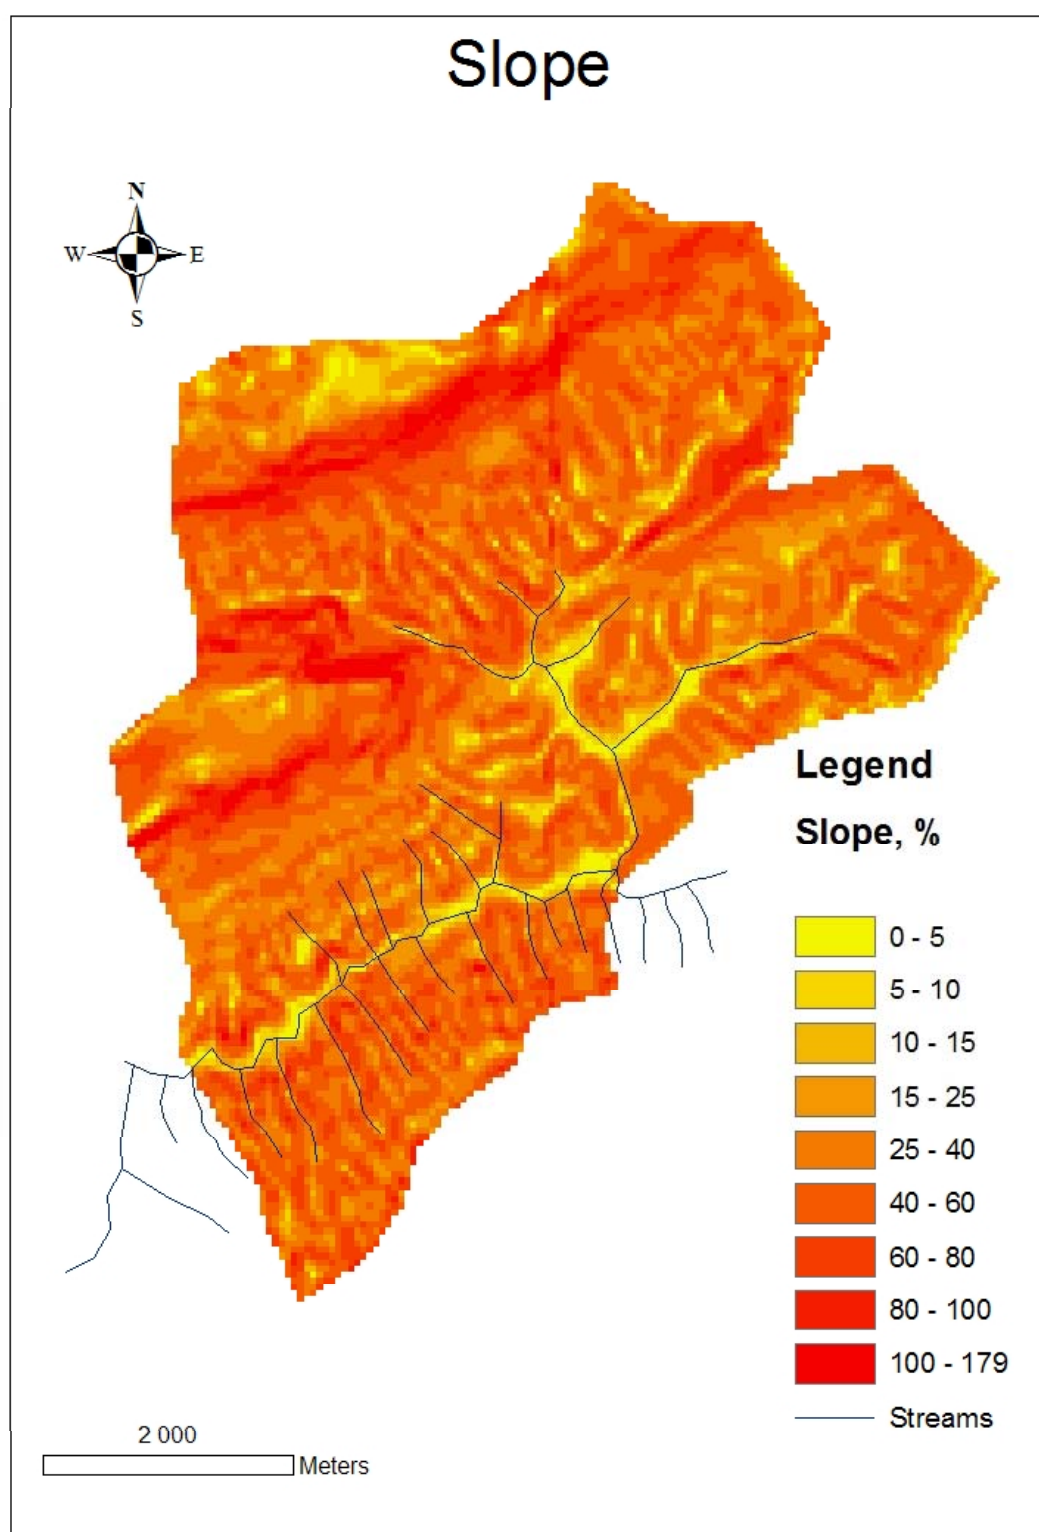
*Fig. 24. Slope classification over the study area. 100% slope corresponds to 45 degrees. (Modified data from NAFRI 2006)*

*Class 4 and 5* - moderate and gently sloping areas that are in less or no need of soil and water conservation measures. Only a tiny plot on the highland plateau falls into class 4. Class 5 does not exist within the study area.

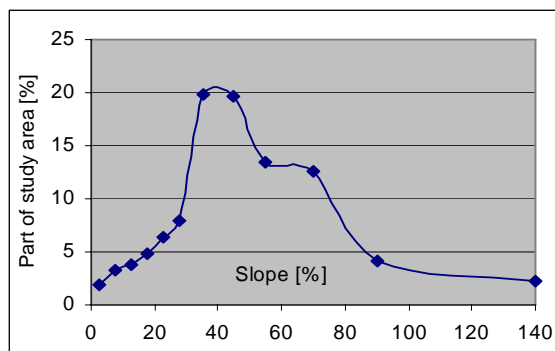
Fig. 25. Graph showing part of the study area with certain slope (data modified from NAFRI 2006).

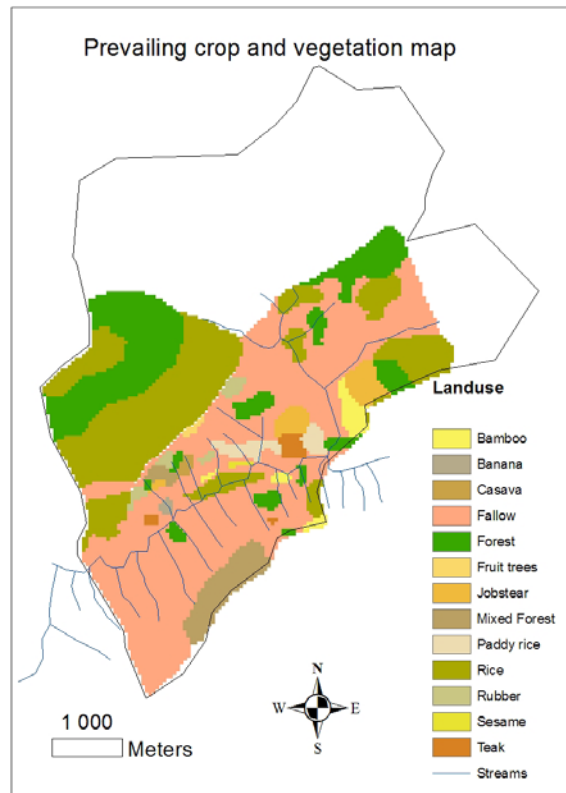
Fig. 26. Prevailing crop and vegetation within study area. For white area, no data were available. (Modified from Sanchez 2007).

A mere 45 % of the area was in fallow 2006. Rice is the main crop cultivated. Upland rice covers 25.5 % percent of the total land cover and paddy rice 1.6 % (Table 12). Not shown in the landuse map is that in some of the rice fields corn is integrated. The difference between “forest” and “mixed forest” is not defined. However “mixed forest” is a relatively small proportion compared to “forest” and together they add up to 21 % of the total landuse. Bamboo, banana, cassava, fruit trees, job’s tears, rubber, sesame and teak occupy small areas, in total about 6.6 % of the area. Not the entire study area was mapped by Sanchez (2007) but the percentage distribution is assumed to be comparable for the whole study area.

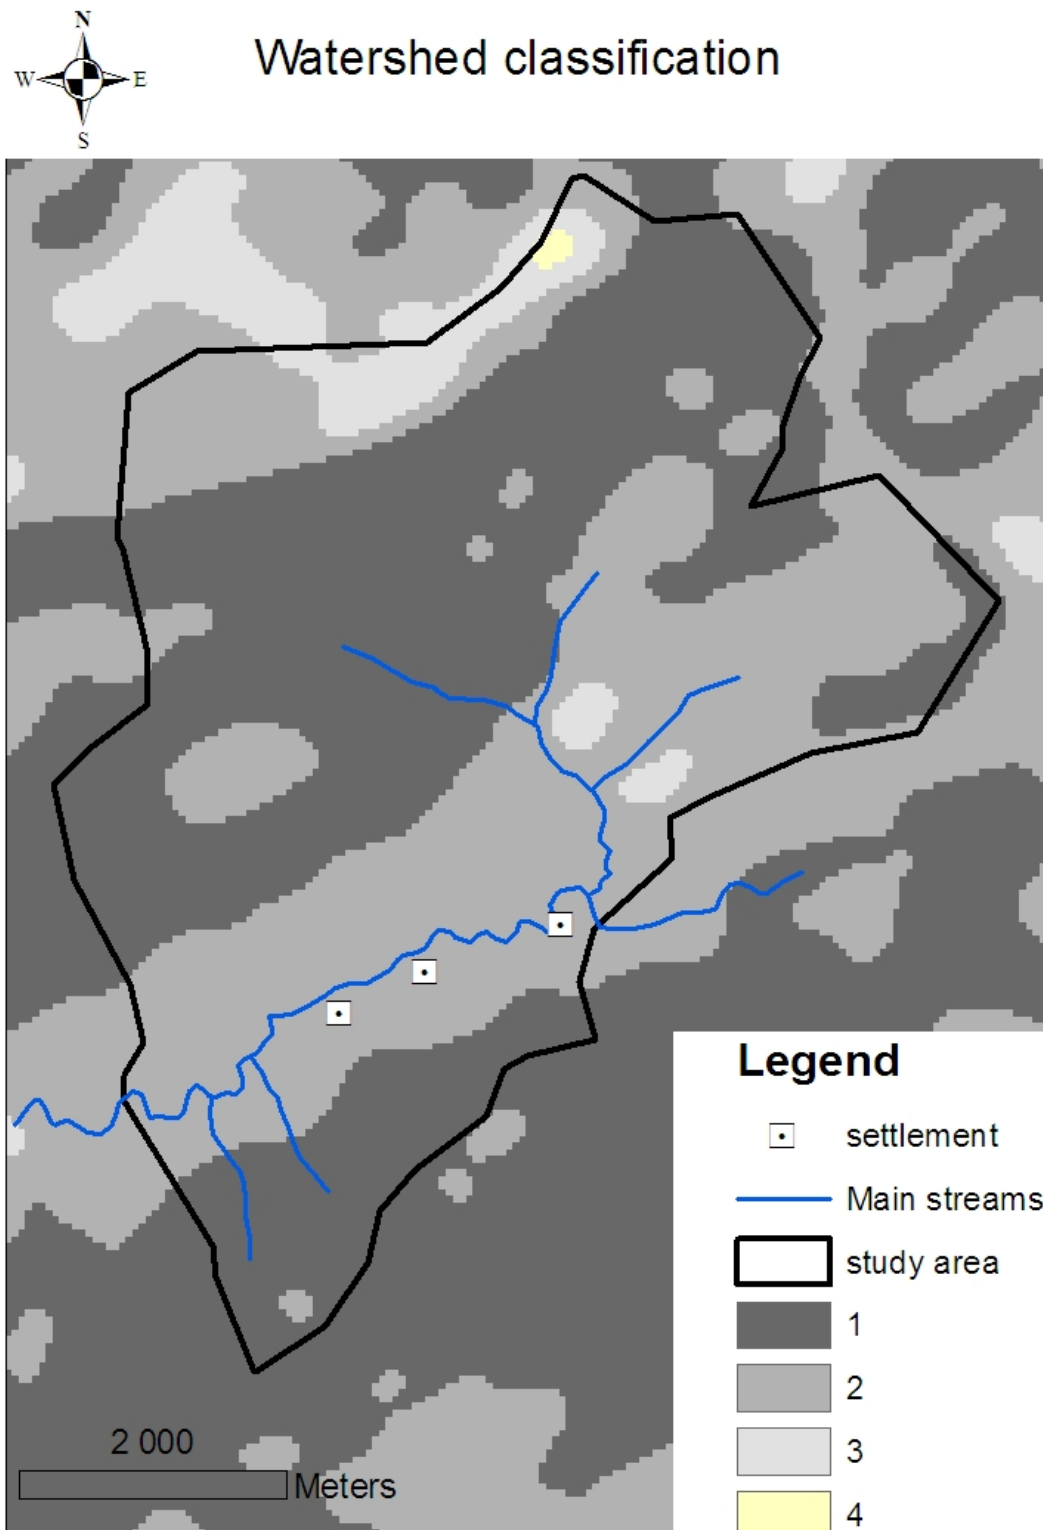
*Fig. 27 Watershed classifications. Class 1 - Very steep slopes, sensitive and need water and soil conservation. Should be kept under permanent forest cover. Class 2 - Less prone to water and soil degradation than class 1, but the slopes are still steep and the recommended landuse is forest. Class 3 - Medium to steep slopes. Conservation measures are recommended and agricultural crops should be accompanied with trees. Class 4 and 5 - moderate and gently sloping areas that are in less or no need of soil and water conservation measures (Modified data provided by NAFRI 2006).*

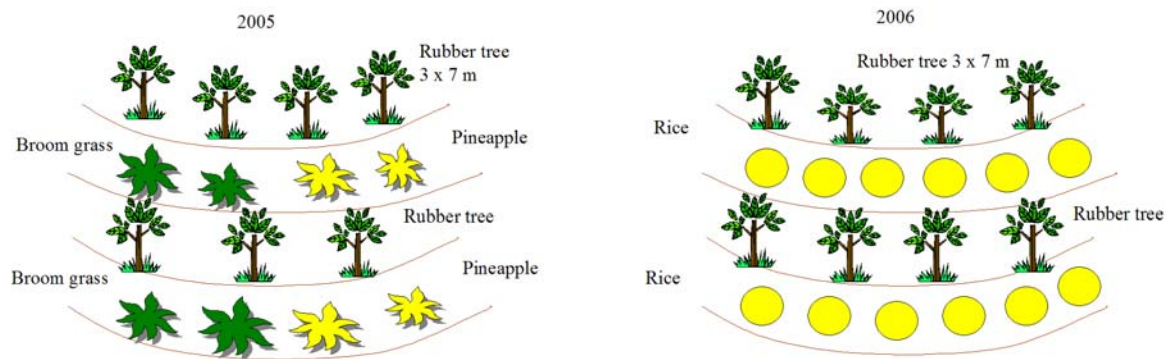
**Fig. 28.** Example of how integrated cropping and contour lining look like in Sida's project in Huay Maha. The left picture shows crops that are grown the first year. The right picture shows which crops that are grown on the same plot the second year.

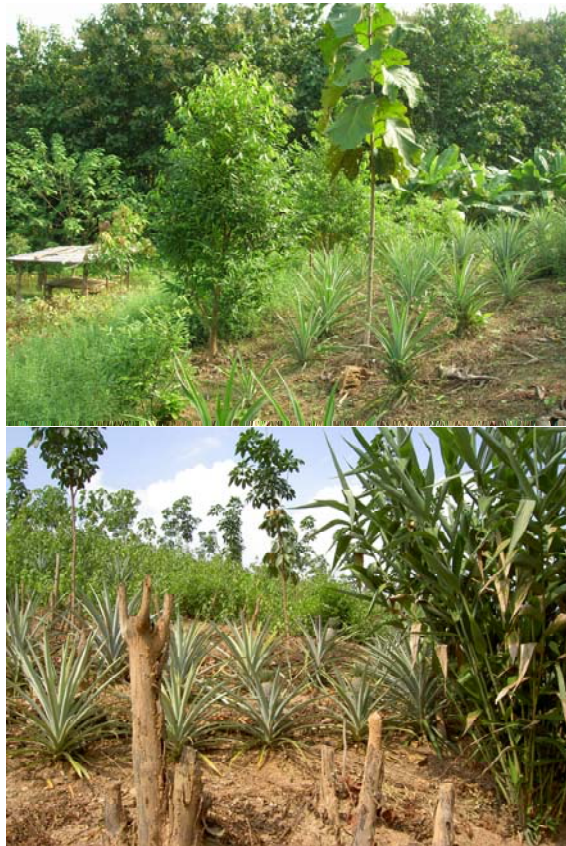
**Fig. 29.** Picture of integrated cropping & contour lining from Sida-project in field (Billving & Ågren 2006).

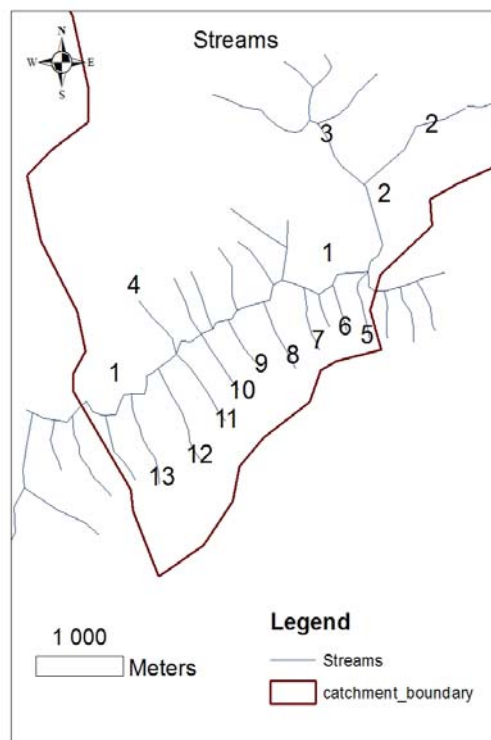
Fig. 30. Map showing the streams in the study area (Modified from NAFRI 2006). See Table 15.

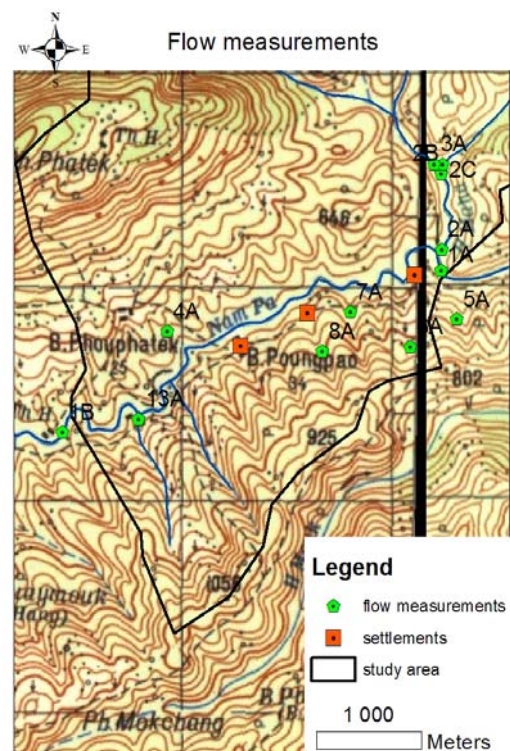
Fig. 31. Map showing location where flow measurements were performed. (Topographic map from NAFRI 2006).

Nam Pa river was measured at it's in- and outflow of the study area (Fig. 31). At the inflow Nam Pa had a cross section of 5.86 m<sup>2</sup> (Fig. 29), an average flow velocity of 1.54 m/s and this gave a flow Q of 9.02 m<sup>3</sup>/s (Table 16). The flow velocity was

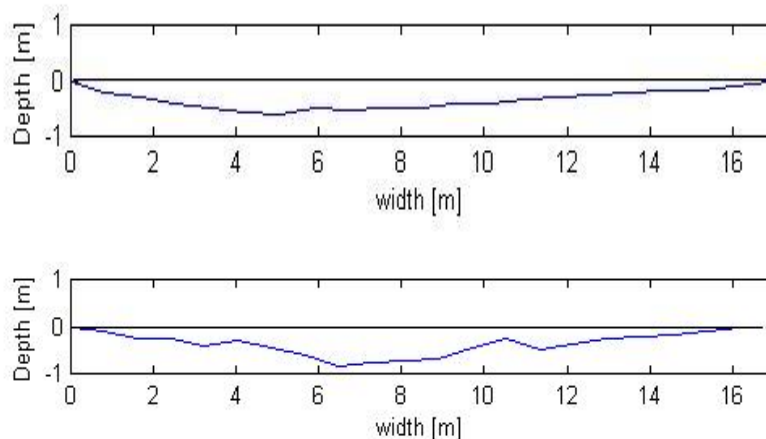
**Fig. 32** Cross sections of Nam Pa river at inflow (upper) and outflow (lower) of the study area 26/10 2006. (Created in Matlab, Appendix VI)

By comparing the in- and outflow of Nam Pa to the area, it seems like Nam Pa has lost 2.26 m<sup>3</sup>/s during its course through the area. This is not realistic, since several streams intersect with the river adding 0.38 m<sup>3</sup>/s to its flow. Since Nam Pa is located at the bottom of a valley and should receive groundwater outflow, the losses are not likely to be much larger than the evaporation. However, the flow patterns in karst areas such as this one may not behave this way. Still it is most likely that Nam Pa receives at least 0.38 m<sup>3</sup>/s during its course through the area at the time of the measurements. Because of this anomaly the flow measurements are viewed critically. As has been discussed previously it is likely that the outflow from the area was underestimated.

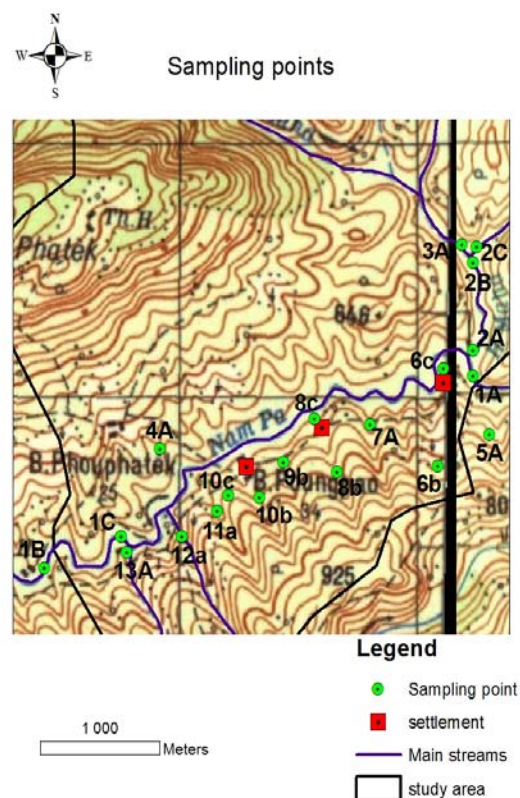
**Fig. 33.** Water sampling locations for chemical analyses of surface water, except for springs & ponds. The indexes are correlated to table 17 & Fig. 30. Capital letters mean samples were taken directly from streams and small letters means that sample were taken from a tank or a tap. (Topographic map from NAFRI 2006).

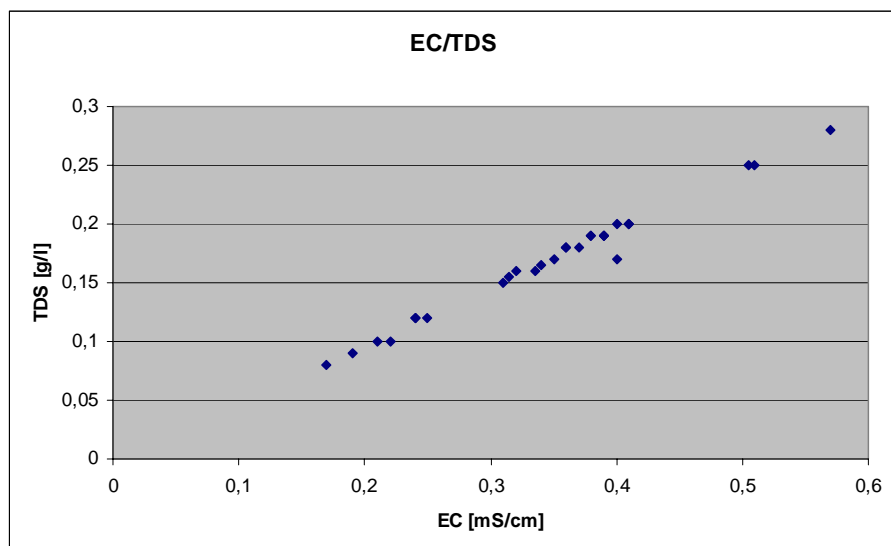
**Fig. 34.** The relation between Electric Conductivity (EC) and Total Dissolved Solids (TDS) in the samples collected in the study area in October-November 2006. (Table 17)

TDS reflects mainly the content of inorganic salts such as for example carbonates, chloride, sulphate and nitrate but to some extent also content of organic matter (DeZuane 1997). TDS varied between 0.08 g/l and 0.28 g/l. The lowest values were for the ponds on the highland and the highest in the springs. Nam Pa and Koa Luang had the lowest values for TDS among the streams. Since TDS is greatly influenced by ionic content, TDS and EC are related. The relation between EC and TDS in these results is linear with EC in mS/cm being on average twice the value for TDS in g/l (Fig. 34).

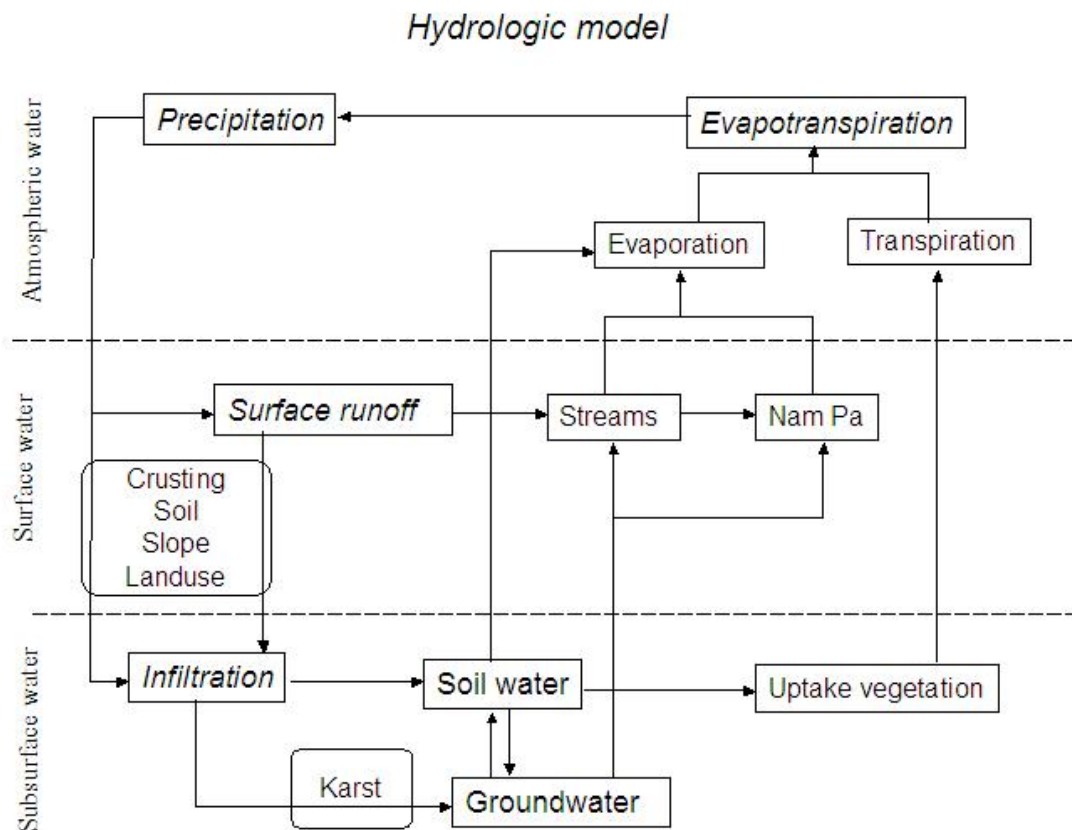
**Fig. 35. Hydrologic model illustrating how water circulates within the study area, reservoirs and important factors that determine flow paths (developed from Chow et al. 1988)**

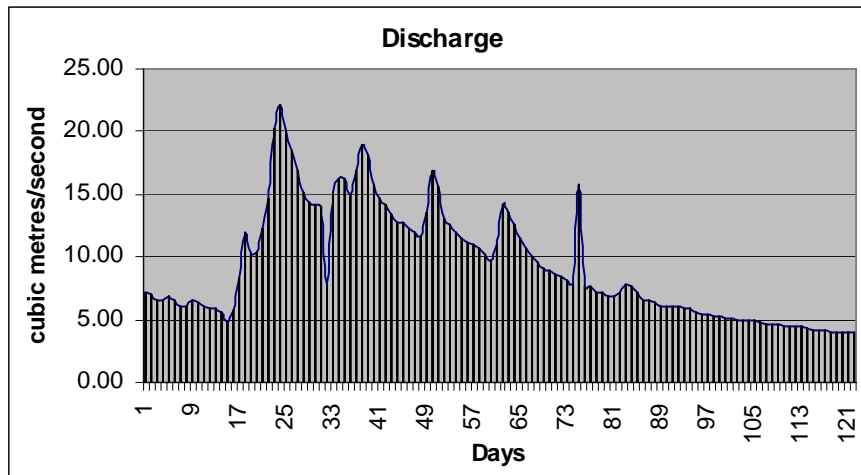
Fig. 36. Discharge data from Nam Pa at Ban Kok Van (Mekong River Commission 1993). Day 1 represents August 1<sup>st</sup>

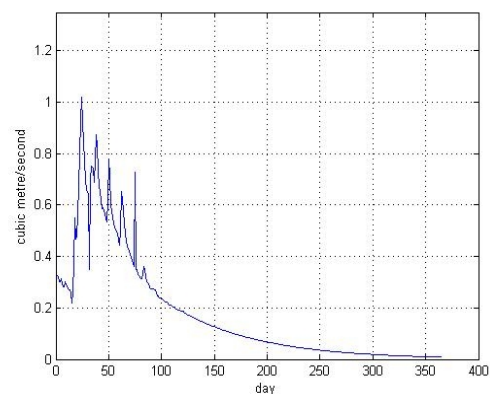
Fig. 37. Baseflow recession curve for Nam Pa at outflow of study area. Day 1 represents August 1<sup>st</sup>. Discharge data from MRC has been modified to correlate to a smaller catchment area. Baseflow recession curve have been calculated in Matlab from formula by Chow et Al (1998) and generates a  $\lambda$  value of  $0.0126 \text{ m}^3/\text{s}*\text{day}$ .

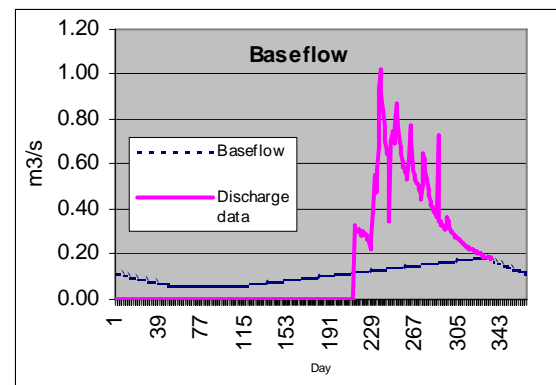
Fig. 38. Baseflow separation from discharge data (modified from Mekong River Commission 1993). Day 1 represents January 1<sup>st</sup> and discharge data available from August 1<sup>st</sup>.

The runoff can be seen as the difference between discharge and baseflow (Chow et al 1988). Since discharge data is missing for parts of the rainy season,
