# **WATER RESOURCES IN THE CULTIVATED UPLANDS OF LAO PDR - A CASE STUDY OF HUAY MAHA VILLAGE**

**A Minor Field Study**

**TRITA-LWR Master Thesis**

LWR-EX-07-28

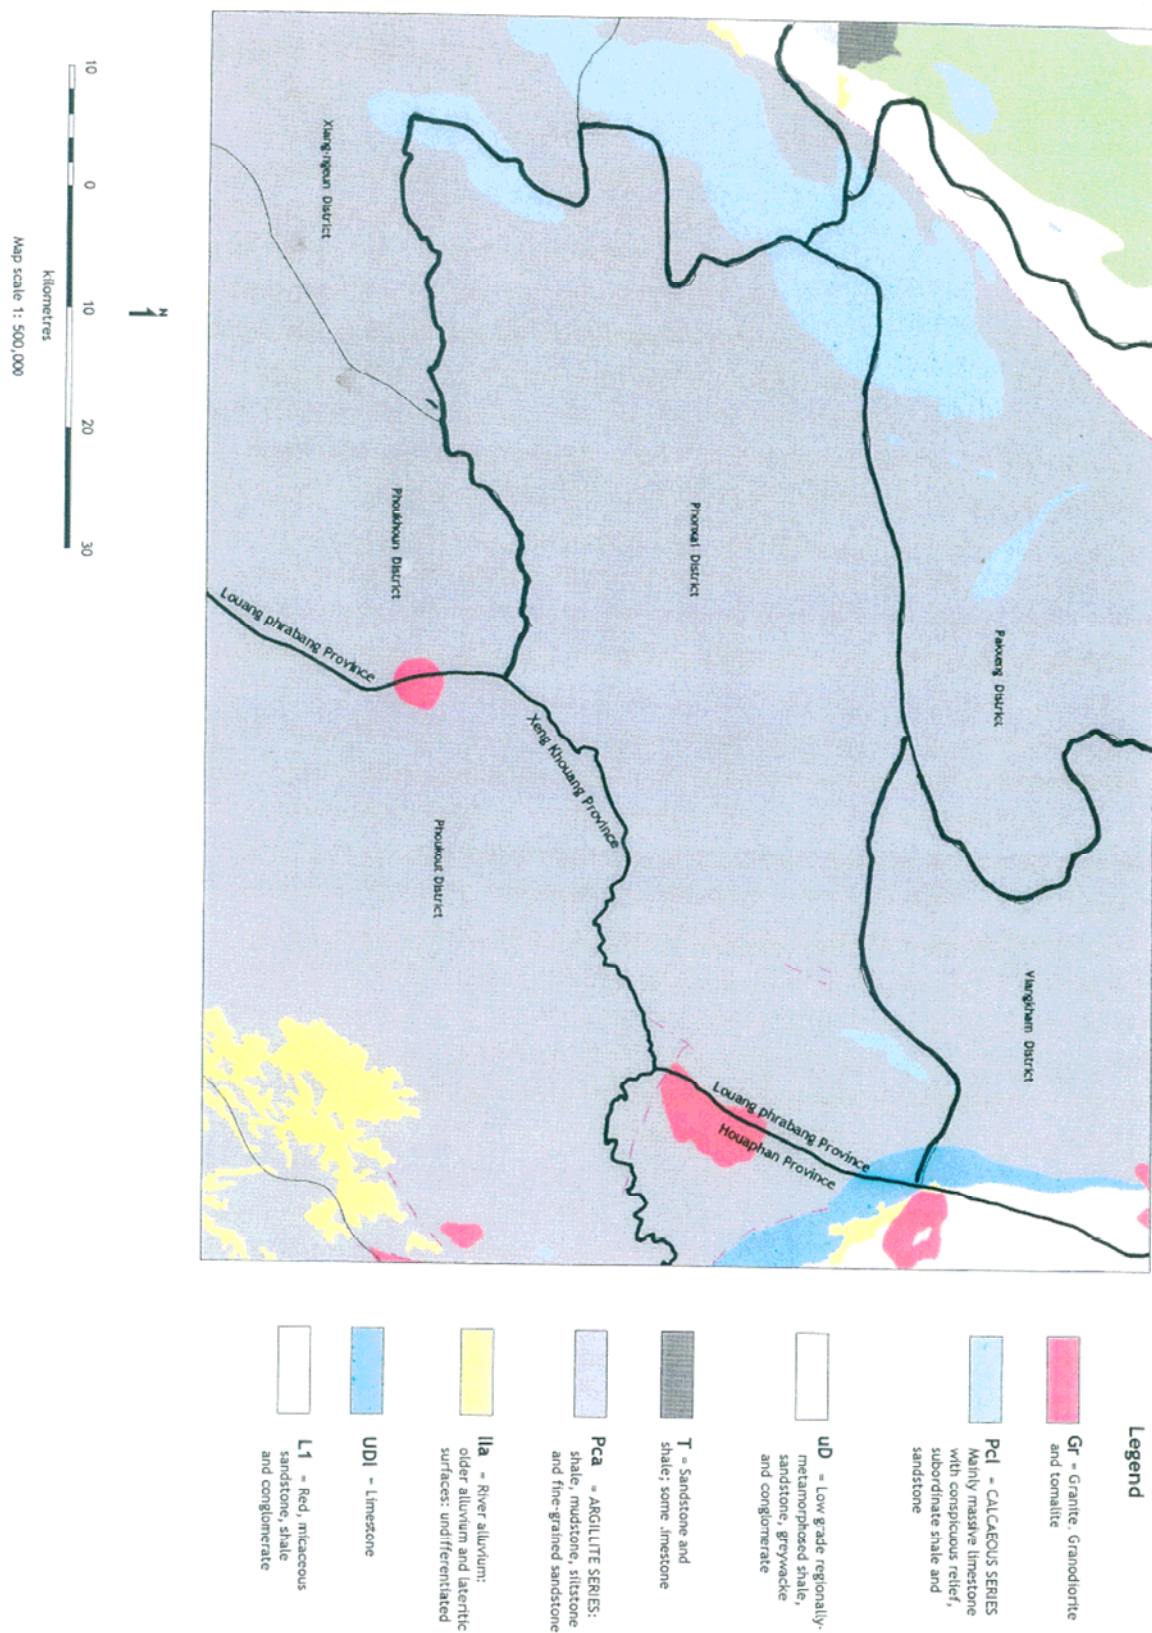
## APPENDIX VIII GEOLOGY MAP PHONXAY DISTRICT

Received from NAFRI 2006
